international magazine of oral implantology

# Resorption mechanism of an injectable calcium phosphate bone regeneration cement – Radiographic and histological monitoring

author\_ Sérgio Alexandre Gehrke, Brazil

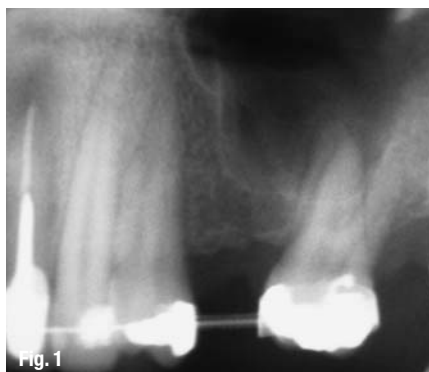
**Fig. 1** Pre-operative radiograph (case I).

The first case is a 30-year old male patient, in good health condition, non-smoker, presenting with absence of tooth 25, with pneumatization of the maxillary sinus.

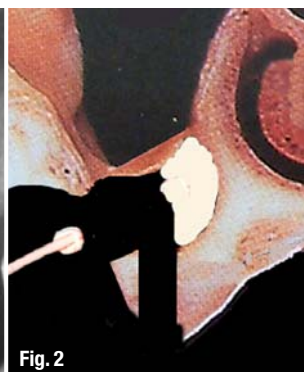
**Fig. 2** Illustration of the installation of the first cement portion, against the inner wall of the sinus cavity.

After administration of a local anesthetic, a lateral access to the sinus cavity was performed through a lateral window. Then, the sinus membrane was carefully lifted up to the desired height. The drilling of the site was performed according to the recommendations of the manufacturer. During this phase, particular attention was paid to avoid perforating the membrane with the drills. A gaze humidified with a vasoconstrictor solution was placed into the sinus cavity for 5 minutes to control the bleeding as efficiently as possible. Indeed, blood flow must be avoided during injection of the VitalOs cement in order to allow contact between cement and bone and anchoring of VitalOs onto the sinus wall. Then, the cement was injected into the sinus to fill the space between the inner (nasal) wall of the cavity and the space prepared for the installation of the implant (fig. 2). Once the cement was hard, the implant was installed as planned. Finally, the rest of the cavity was filled up with VitalOs up to the edges of the lateral window, without using a membrane. Indeed, the use of a membrane is not necessary with VitalOs, since the product acts itself also as a barrier.

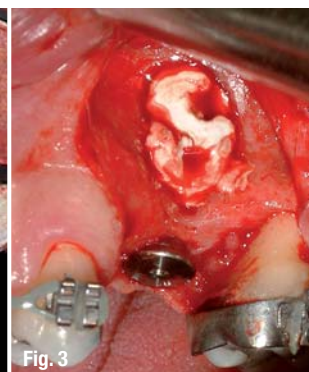
**Fig. 3** Sinus cavity completely filled with VitalOs, after installation of the implant.

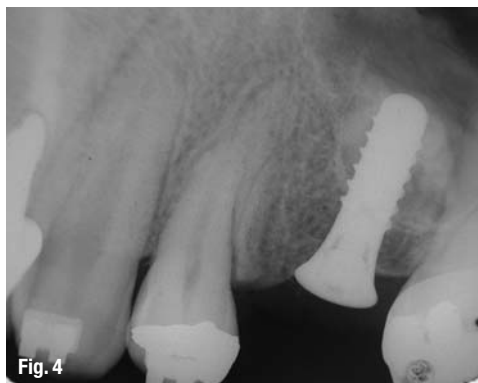
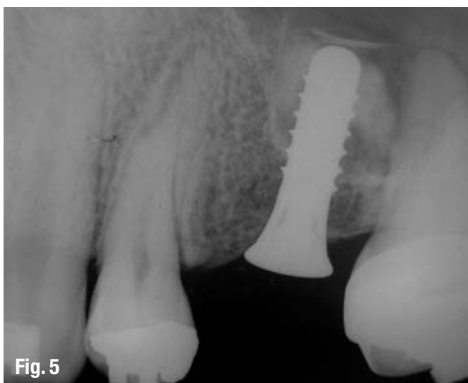
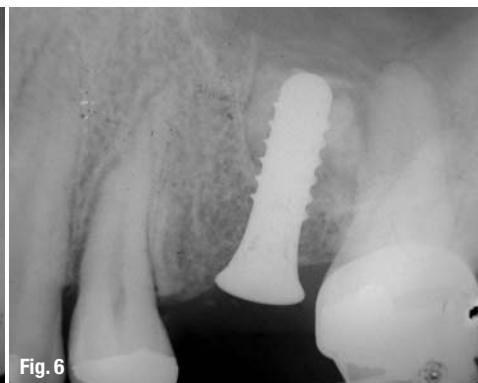
**Fig. 4–7\_** Radiographs of case I at 30, 60, 120 and 180 days after surgery.

Thanks to the adequate radiopacity of the cement, it is easy to perform a radiographic follow-up and analysis of the resorption and new bone growth. Radiographs were therefore taken at 30, 60, 120 and 180 days after implant installation (figs. 4–7), as well as 12 months (fig. 8) after installation of the restora-

talOs cement. This process progresses towards the center of the cement mass. In the sinus lift case, the progress also takes place from the coronal towards the apical region around the implant (yellow arrows on figure 4). Across the different times of analysis it is possible to see that the material is gradually being replaced and the osseous tissue is being formed, apparently without incorporation of cement particles. At the end of the neoformation process, the newly formed bone displays radiographic characteristics which are similar to those of the native surrounding bone. This is also confirmed after 12 months of loading, where the bone around the implant has not resorbed, indicating a good preservation of the new osseous volume around the implant.

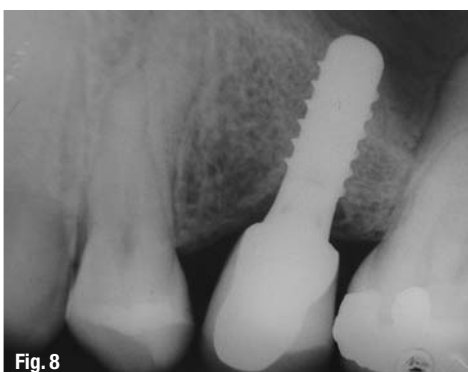
**Fig. 9\_** Pre-operative radiograph (case II).

The second case is a 40-year old female patient in good health condition, non-smoking, presenting with a fracture of tooth 14 and presence of a large radicular cyst (fig. 9) requiring removal of the root. The site presented a very large loss of bony structure, with fenestration of the buccal side of the socket wall. Therefore, the implant could only be stabilized in the inferior wall of the sinus cavity with the use of Summers' osteotomes.

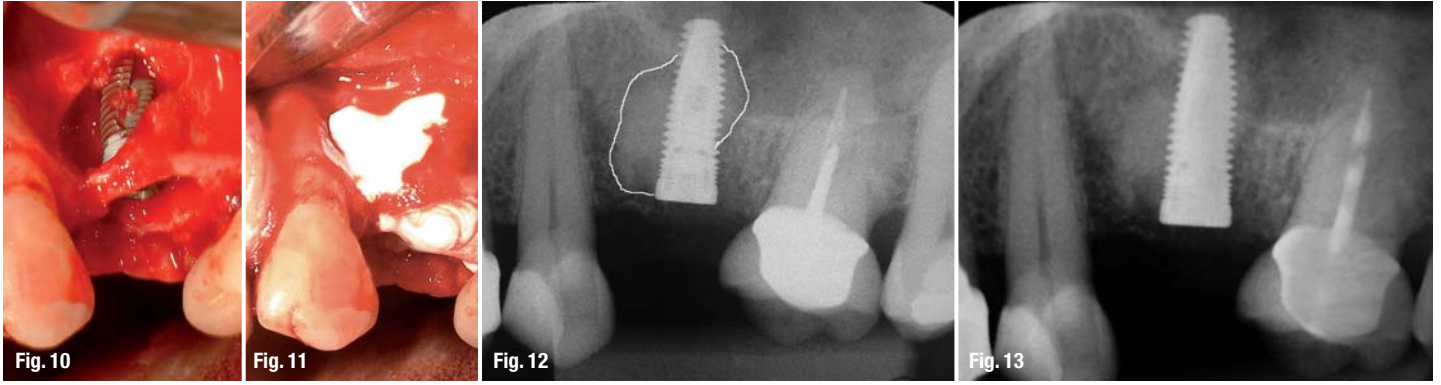
**Fig. 12–15**\_ Radiographs of case II at 30, 60, 120 and 180 days after surgery.

**Fig. 16**\_ Radiograph of case II taken 12 months after loading.

The control performed followed the same schedule described for the case I, i.e. radiographs were taken at 30, 60, 120 and 180 days after implant installation (figs. 12-15), as well as 12 months (fig. 16) after installation of the restoration.

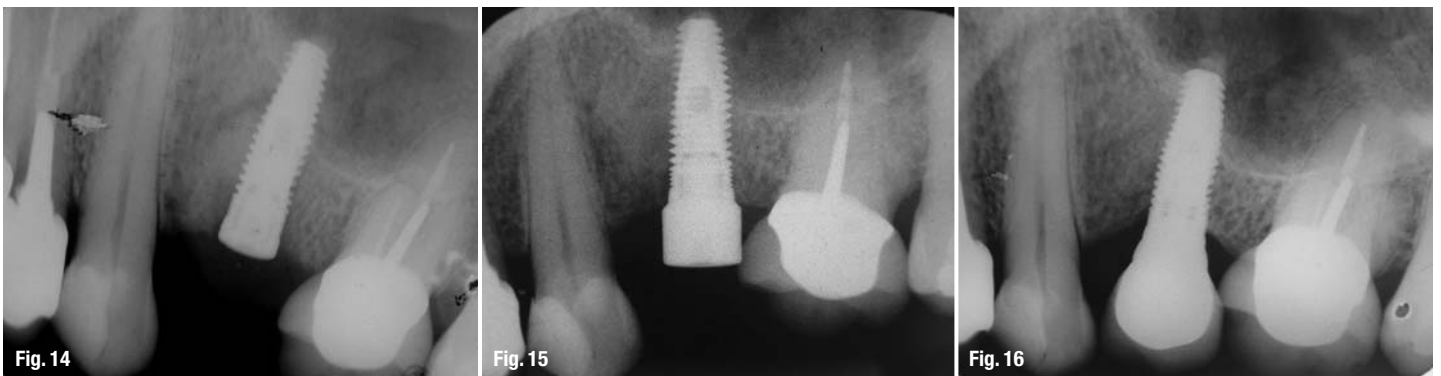
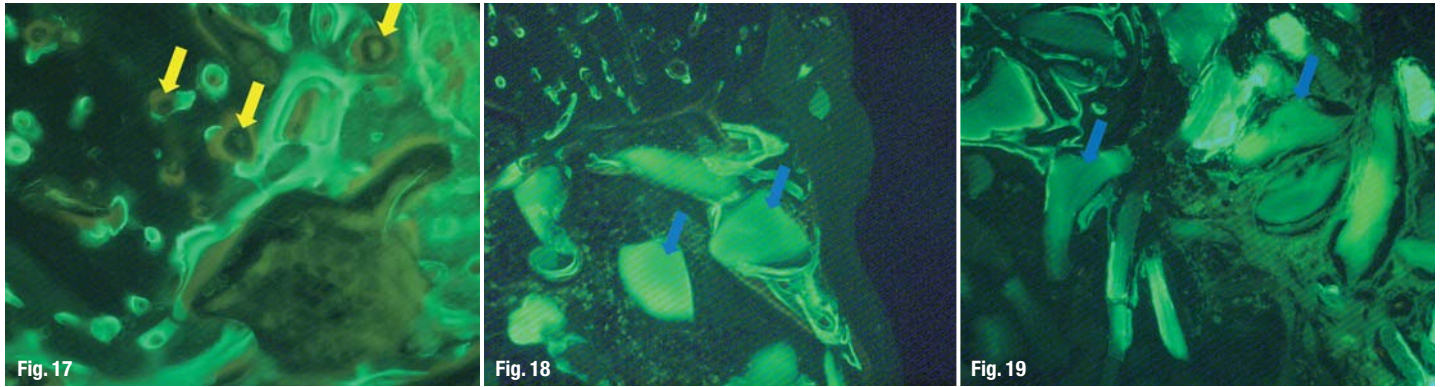
**Fig. 17–19** Fluorescence histologies of sites filled with VitalOs, Bio-Oss and Bone Ceramic respectively.

The results of the histological study show that the injectable brushite cement resorbs much more uniformly and rapidly than the granular materials (figs. 17-19). It is also possible to state that the ossification process in the defects filled with VitalOs starts in the first weeks after augmentation: intensive brick-red areas due to alizarin indicate bone deposition between the second and the fourth week, and green areas due to calcein reveal the osteogenesis activity after 4-6 weeks. The coloration of the osteogenesis areas is more intense at every follow-up stage in the defects filled with the cement than in those filled with granular materials. This shows the maturity of the bone in the sites grafted with the brushite cement. Moreover, the organization of this newly formed bone tissue presents a structure which is more suitable for subsequent implant installation, i.e. a more organized and lamellar bone, with presence of osteons (yellow arrows, fig. 17).

New bone formation is also seen in the defects grafted with granules. However, the bone deposition is stronger in the calcein phase (green fluorescence, see fig. 18-19) than in the alizarin one (red), which indicates a delayed bone formation, starting 4 weeks after surgery. The fluorescence of the new bone tissue is weaker than in the sites filled with PD VitalOs Cement, which is a sign for lower maturity of the new bone tissue.

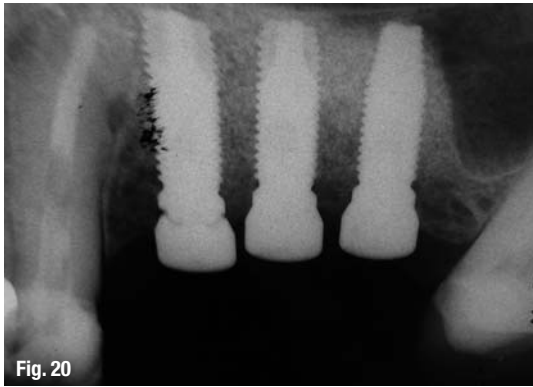
Fig. 20

**Fig. 20, 21** Radiographs of a case augmented with Bone Ceramic: 180 days after surgery and 1 year after crown installation, respectively.

The radiographic monitoring is more difficult to achieve with granular materials because their appearance on radiographs is closer to that of bone and the grafted area becomes eventually a mix of granules and bony tissue. To emphasize this, figures 20 and 21 show radiographs of sites augmented with granular materials (Bone Ceramic), 180 days after augmentation and one year after crown installation, respectively. It can be seen that the newly formed bone is not as well defined as in the cases filled with the brushite cement (fig. 15). The resorption mechanism of granular materials is also accompanied by new bone formation, but this takes place between the granules, most of them remaining eventually embedded in the new bone structure.
